Recommended Updates to the Integrated Forest Management Plan

**The Woodlands Township**

## **Recommended Updates to the** Integrated Forest Management Plan The Woodlands, Texas

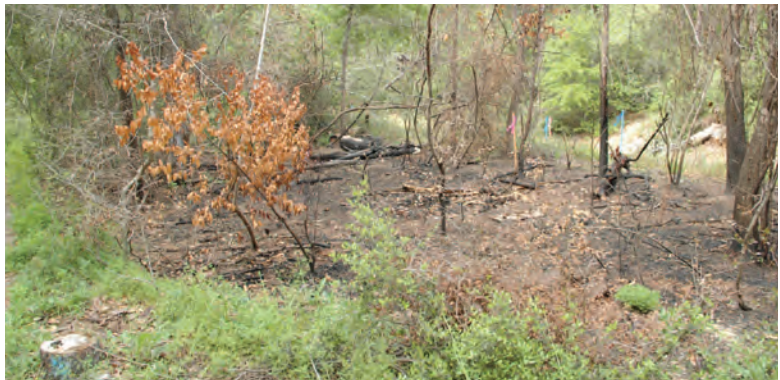
*A small fire scar was noted in Logger’s Hollow during site inspections. The cause of the fire is unknown however, the fire was limited to the space between the open drainage area and the walking path indicating the effectiveness of firebreaks.*

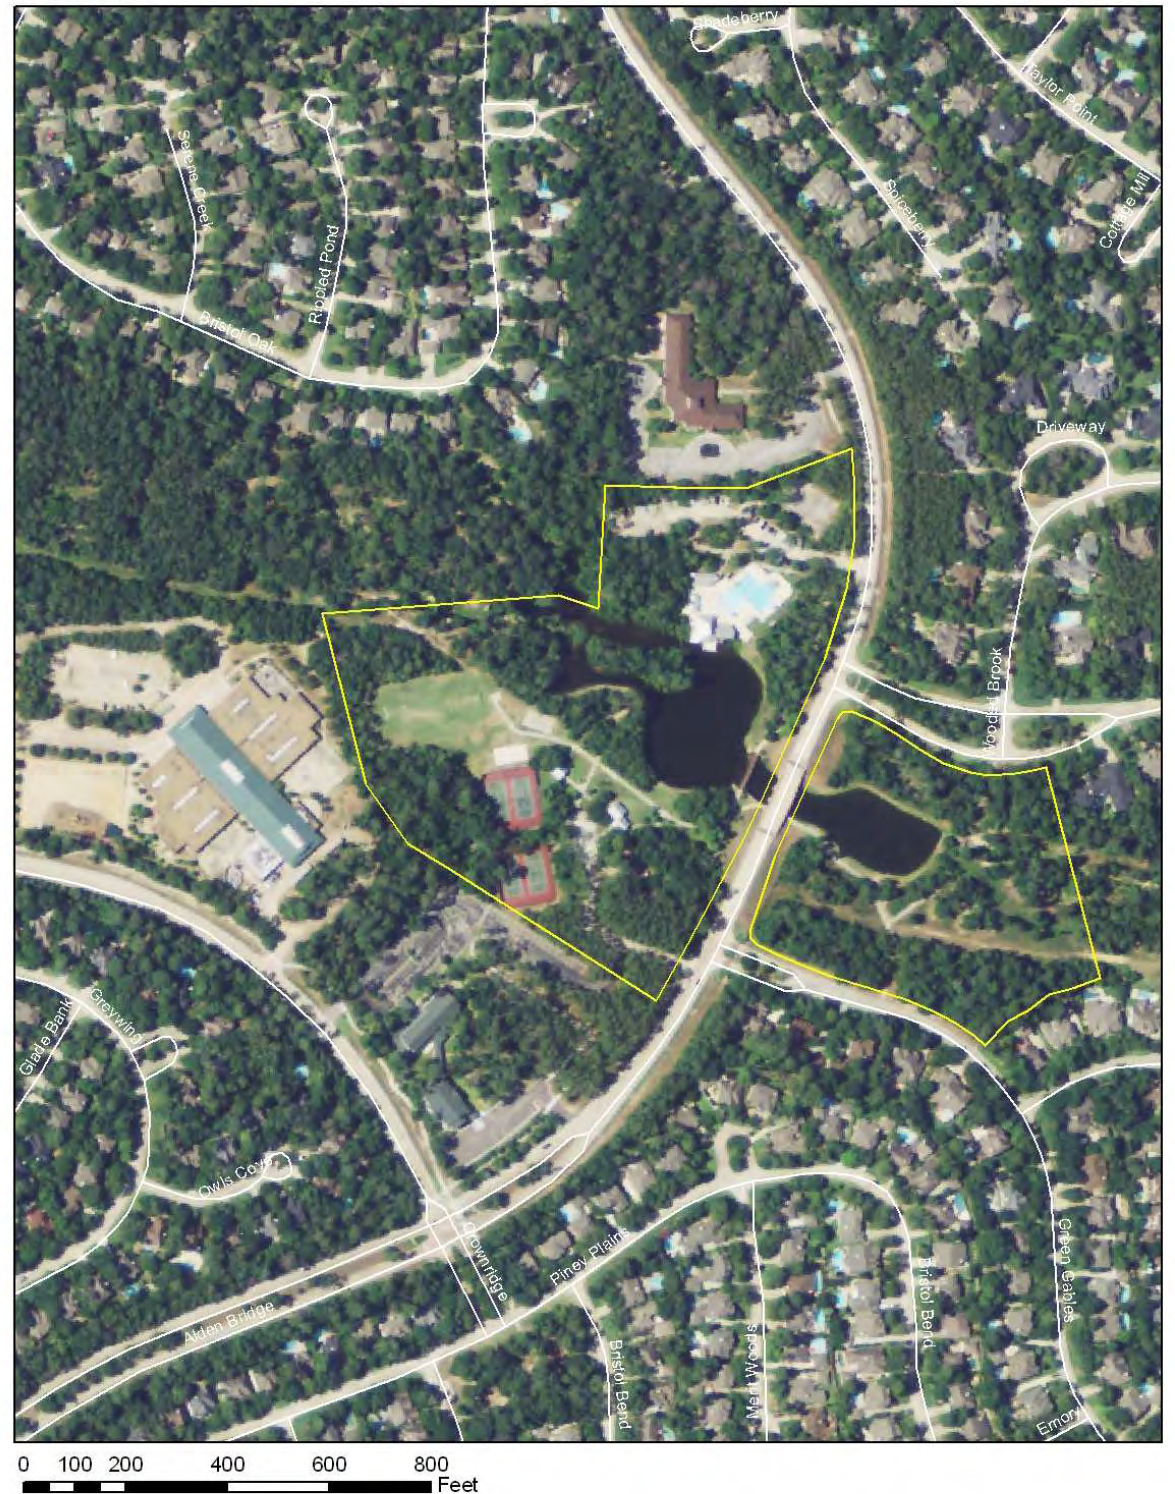
Available planting space found near the lower pond.

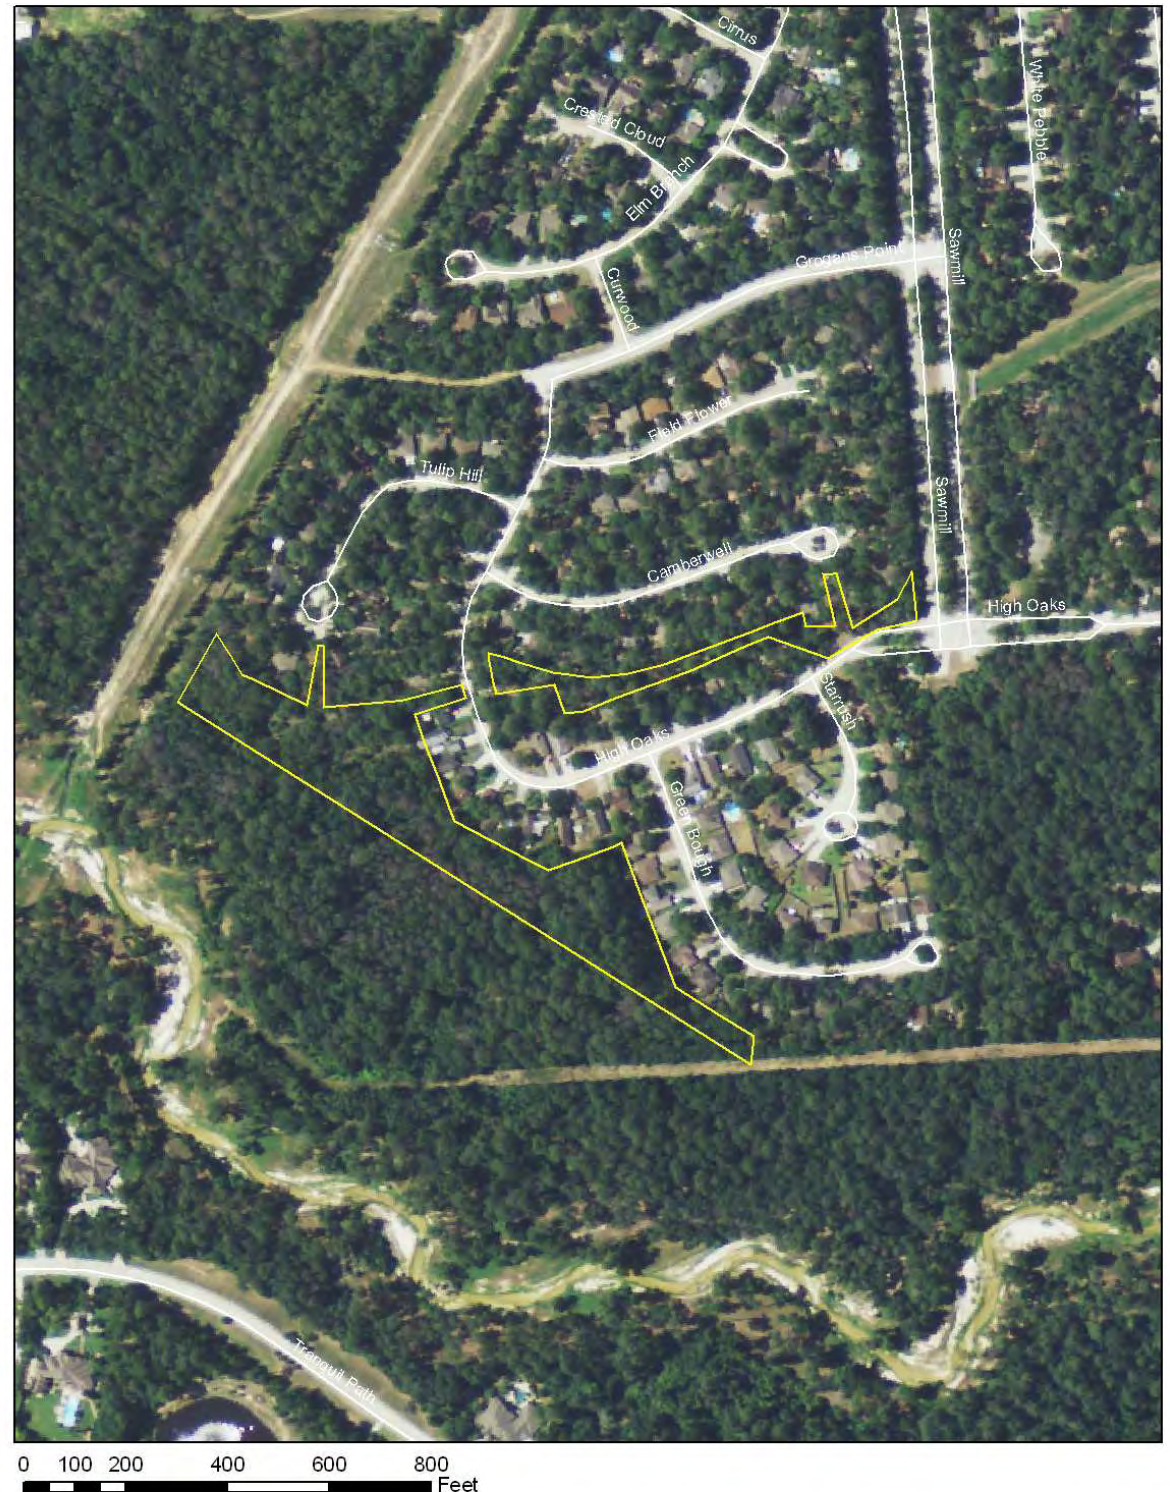
Dead trees noted within Camberwell Ct. reserve.

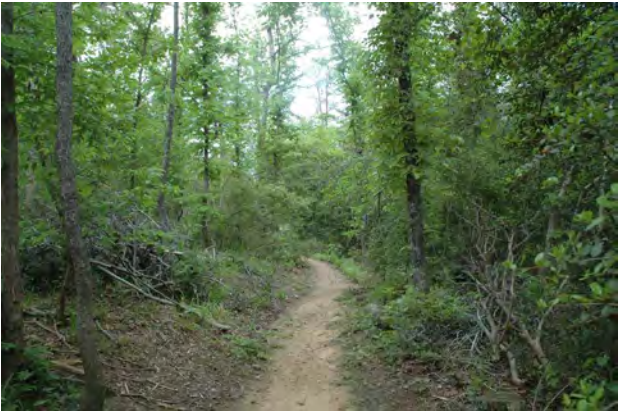
A natural footpath was found running through the center of the site.

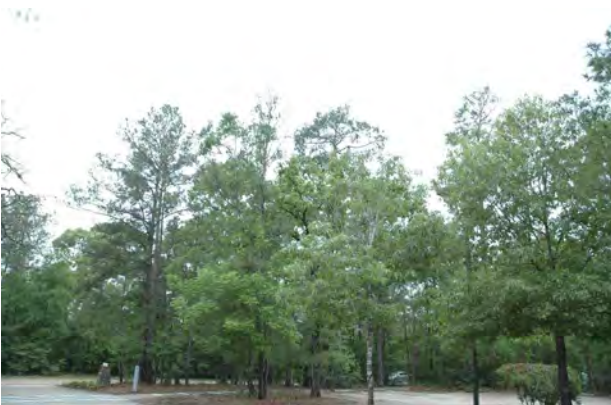
The parking lot has numerous shade trees that should be monitored during the course of routine maintenance to prevent deadwood or other hazards from falling on cars or people.

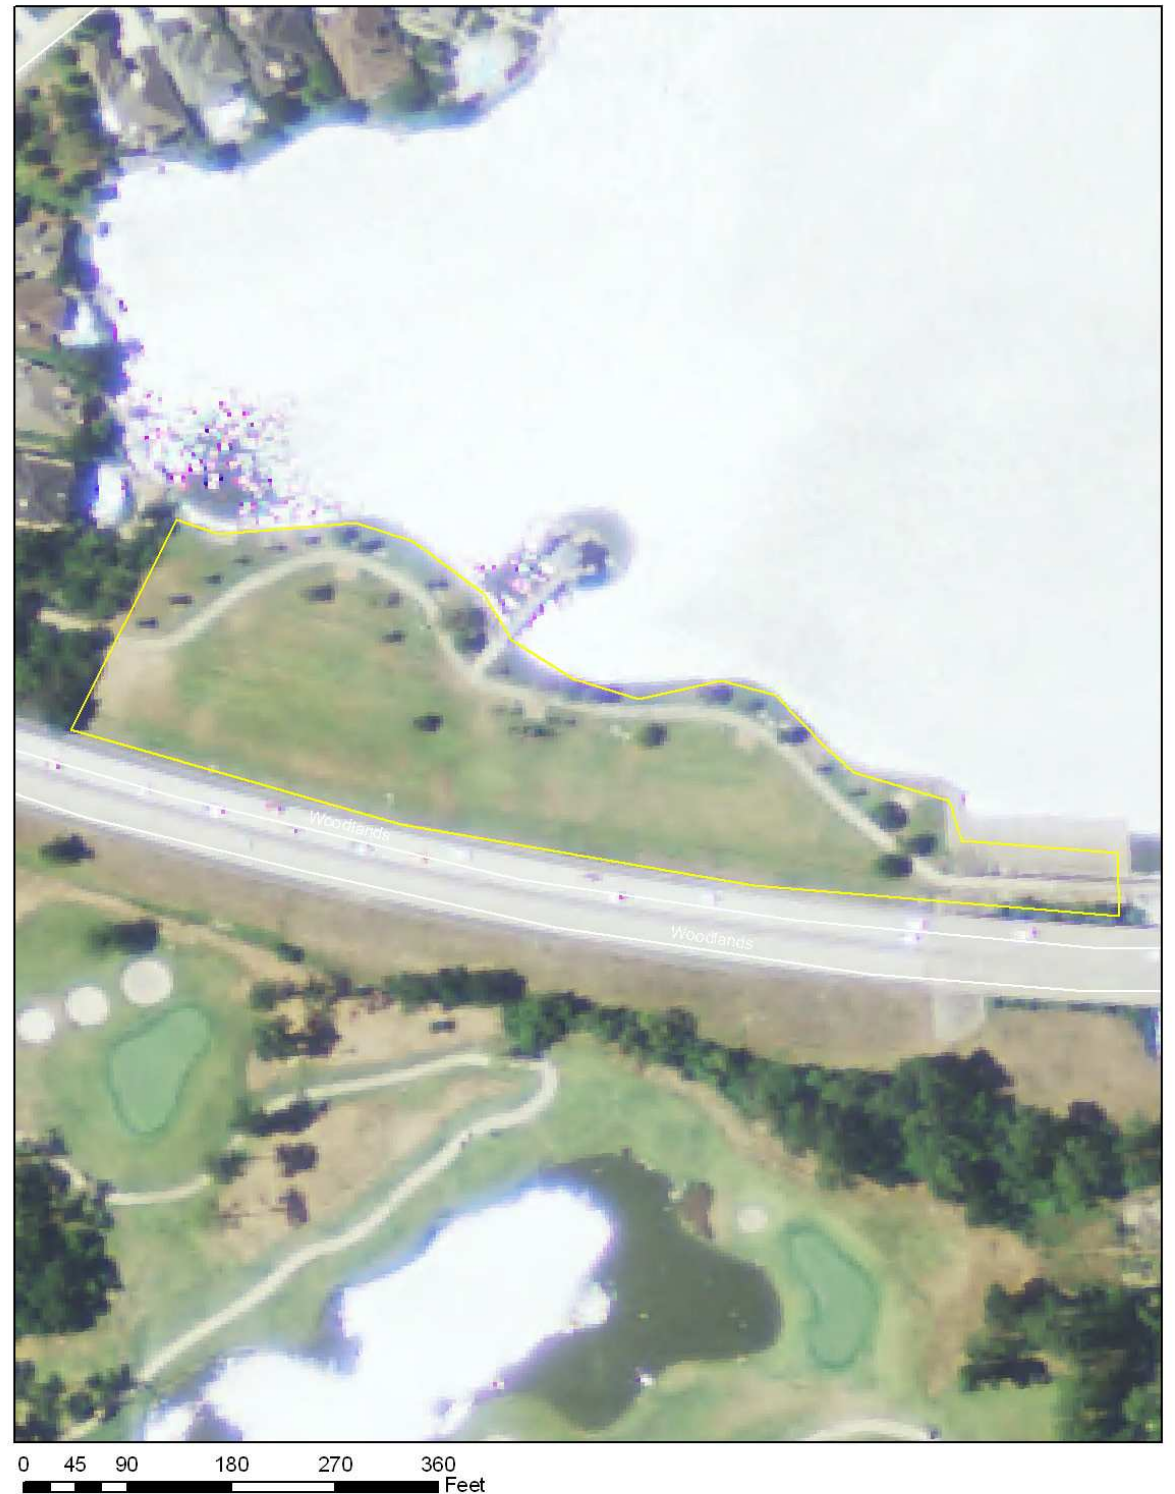
Significant planting space is available on this site, without detracting from the intended view.

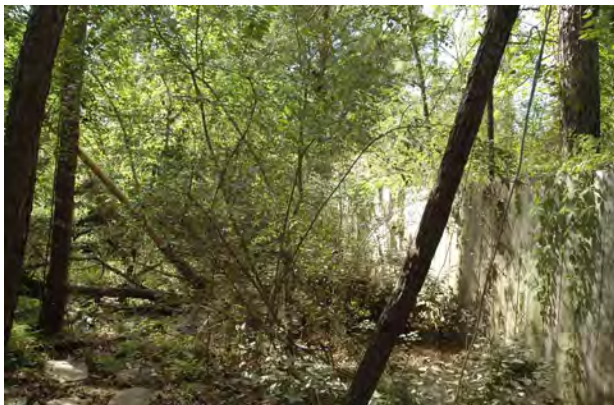
Vegetation growing up to back of fences.
