Recommended Updates to the Integrated Forest Management Plan

**The Woodlands Township**

## **Recommended Updates to the** Integrated Forest Management Plan The Woodlands, Texas

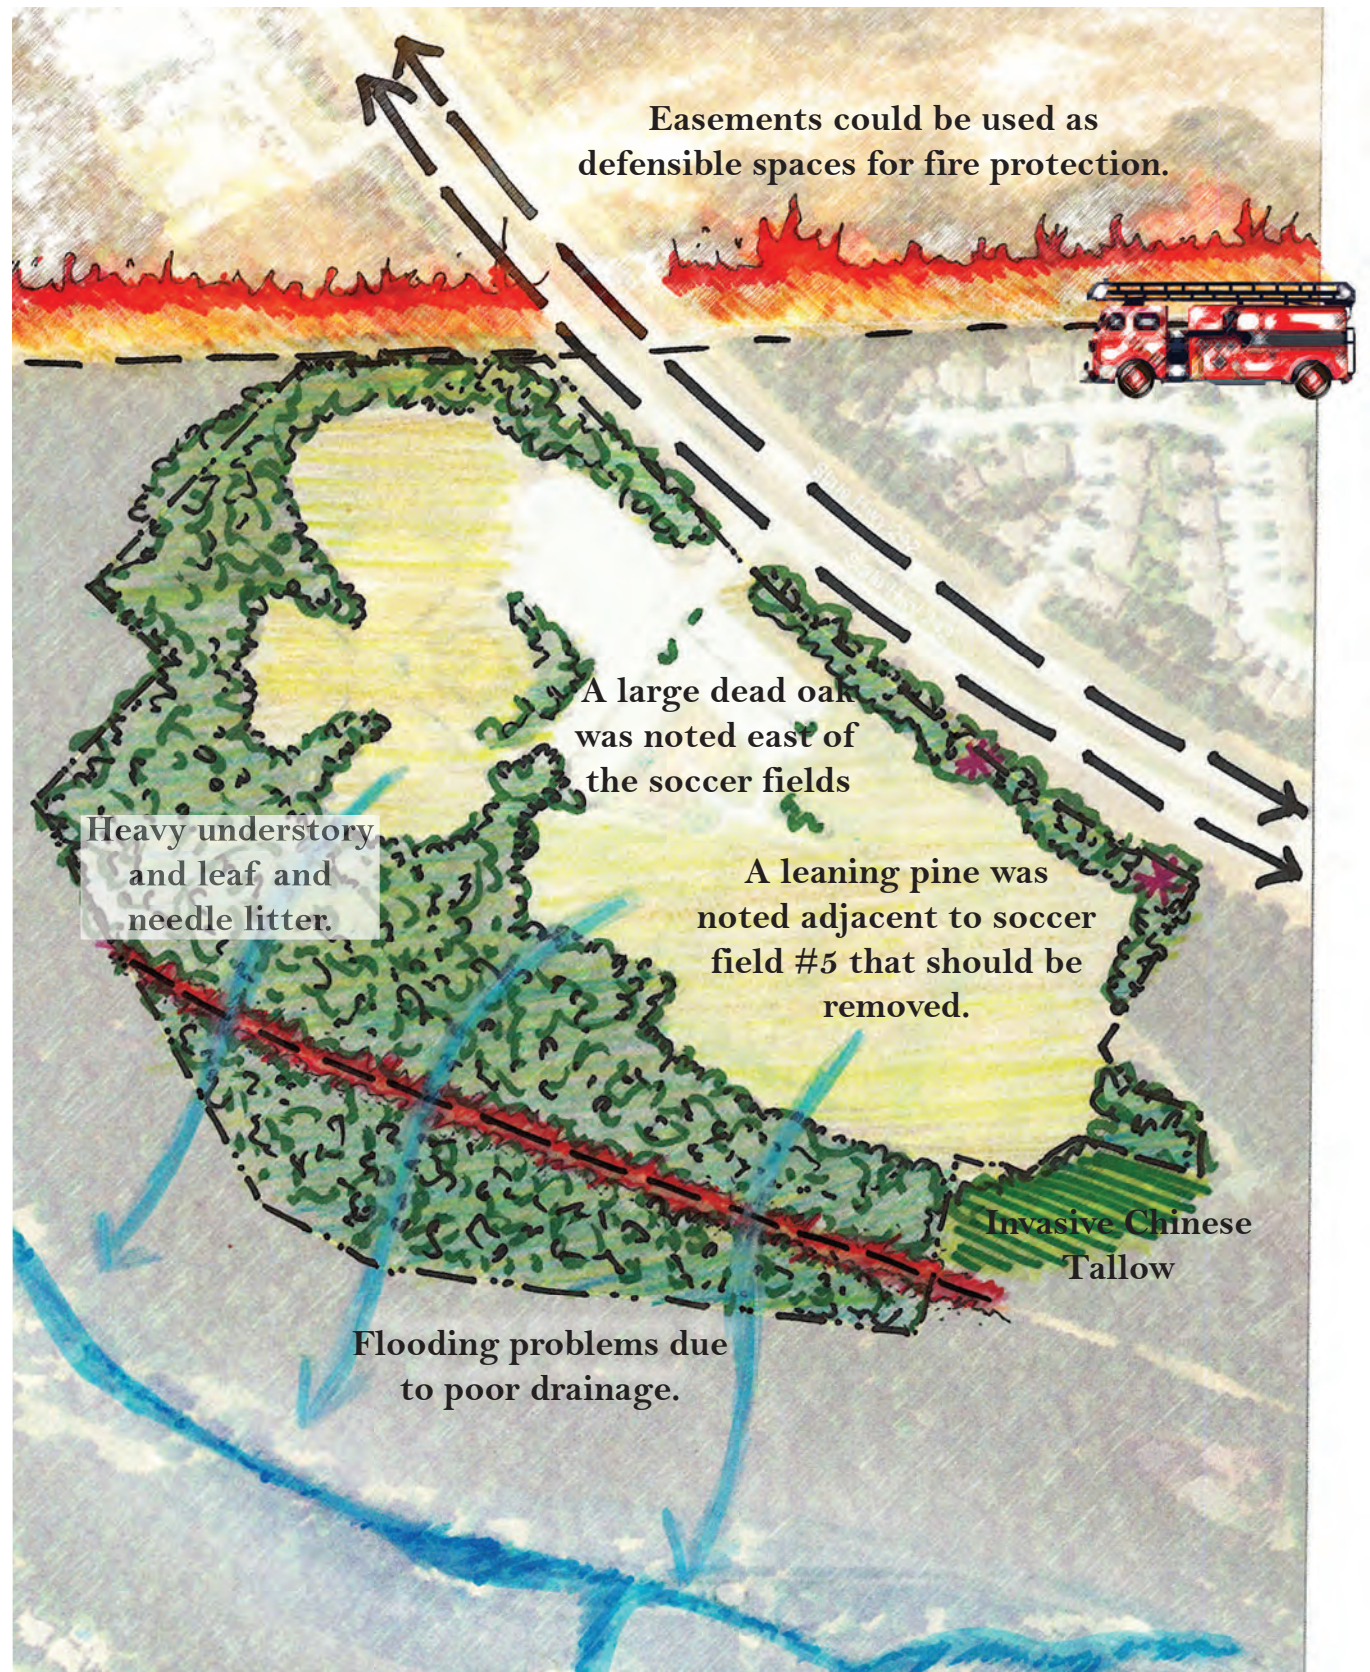
*Analysis Diagram of Key Findings for Alden Bridge Sports Park: Key findings are typical for all inspected reserves and included reforestation, tree health, safety, drainage, fire risks, and invasive species.*

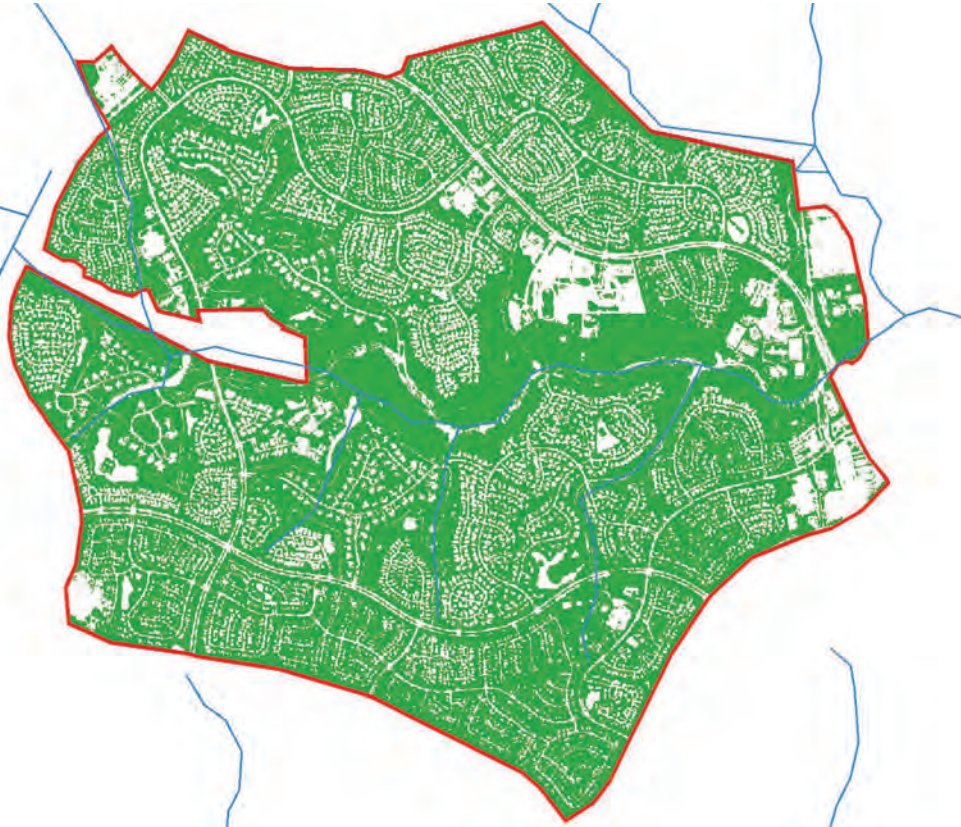
*2004 canopy analysis of the Village of Cochran's Crossing. (Tree canopy shown in green)*

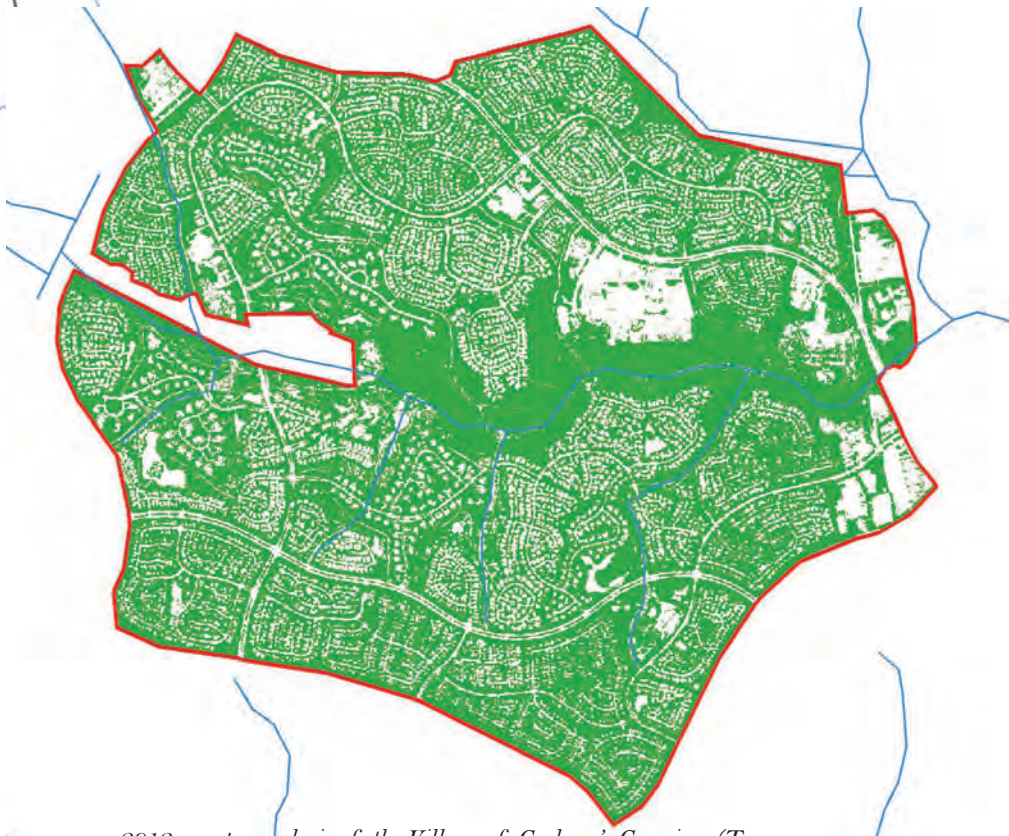
Cochran's Crossing showed the greatest increase in canopy with a remarkable gain of 27.91% over 8 years. The changes in canopy appear subtle and are small gains at the individual tree level however, collectively they add up to a large overall increase. This increase may be due to the soils and available moisture in the area.

*2012 canopy analysis of the Village of Cochran's Crossing. (Tree canopy shown in green)*

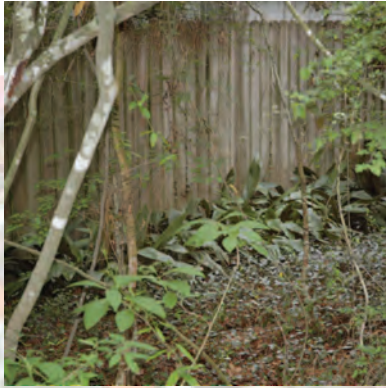
*Evidence of introduced plants that have escaped landscape environments, possibly due to dumping of landscape debris. (Left)*

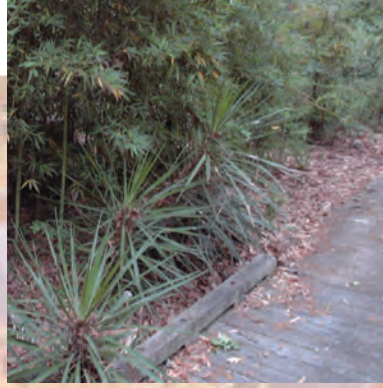
*Bamboo and palm species have been introduced in Millbend Common along with numerous other tropicals and citrus. (Left)*

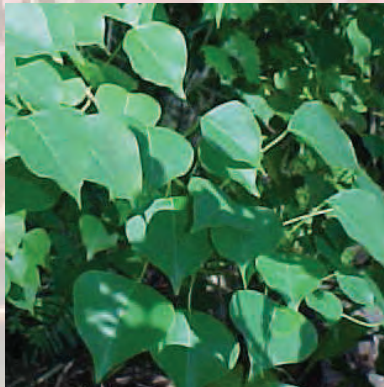
*Chinese Tallow leaves with their distinct heart shaped form. (Right)*

Chinese Tallow (*Triadica sebifera*), one of the most invasive and problematic species in the Southeastern United States was noted on the property. First introduced in colonial times as an ornamental and for soap making, it was brought to Texas in 1949 and has spread across the southeast. It is a prolific seed producer, shade tolerant and re-sprouts easily to out-compete native vegetation. It can be controlled with a variety of herbicides and the existing plants are fairly easy to eradicate. The seed source is what makes total elimination difficult as it must be treated yearly to remove seed sprouts. The best way to control Chinese Tallow species is with an approved herbicide by basal spray, foliar spray or frill and spray. Control depends on the size and number of stems to determine the most economical and efficient methods. Inspections should be made periodically to monitor for excessive understory cover, which, reduces opportunity for natural pine regeneration.

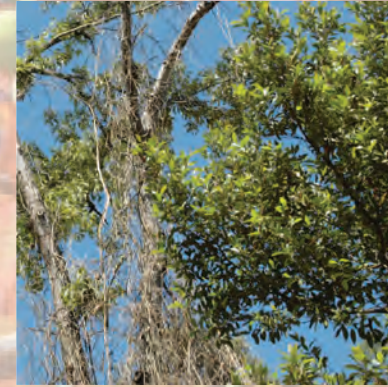
*Vines accumulating in a tree within an open space reserve at Camberwell Court/West High Oaks. (Right)*

We recommend that you continue to conduct vine removal operations with emphasis on removal of vines from reforestation sites and the removal of noxious vines such as Greenbriar and Poison Ivy.

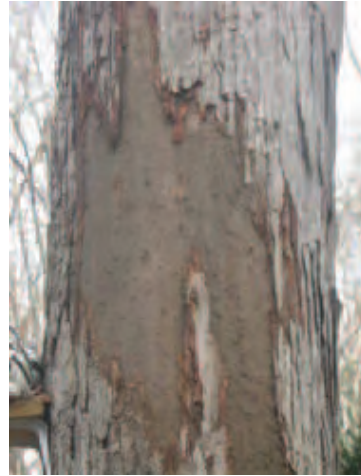
*Hypoxyylon canker damage.*

Hypoxyylon canker is classified as a white rot fungus that is usually considered a weak pathogen and not aggressive enough to take over healthy tree. It is only of consequence when the trees are under severe stress due to drought or other injury. As the fungus develops underneath the bark, it causes the bark to pop loose and slough off, exposing a mat of grey, tan olive green or black powdery spores. It is the main cause of mortality in both Red Oak and White Oak species; but has been particularly damaging in Water Oak and Willow Oak which is reflected in the mortality survey done by AFM. Once the tree becomes infected and begins to show the black and grey patches, it most likely will die and needs to be removed. Forestry workers for The Township need to learn to recognize trees that are infected with Hypoxyylon canker and to take action by removing the tree if it may cause a hazard situation.

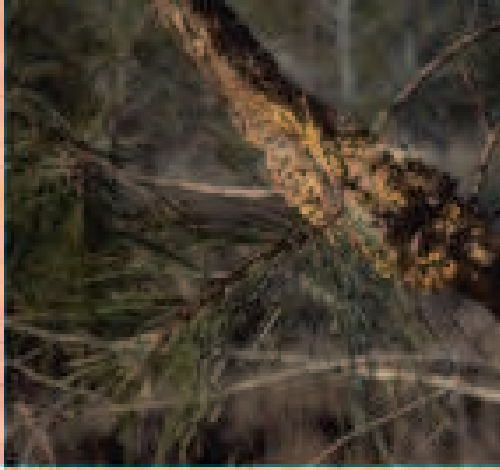
*Fusiform Rust gall on pine branch.*

1. Plant only rust-resistant pine seedlings.
2. Wood-rotting fungi and insects invade large galls or large open wounds on pine. These will weaken the tree. Remove trees with larger galls or open wounds near buildings because of the possibility of damage from wind breakage.
3. Engage a certified arborist or other forest professional for proper disease identification and treatment.

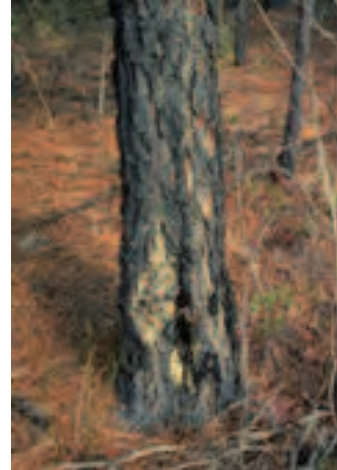
*Rust gall on pine trunk.*

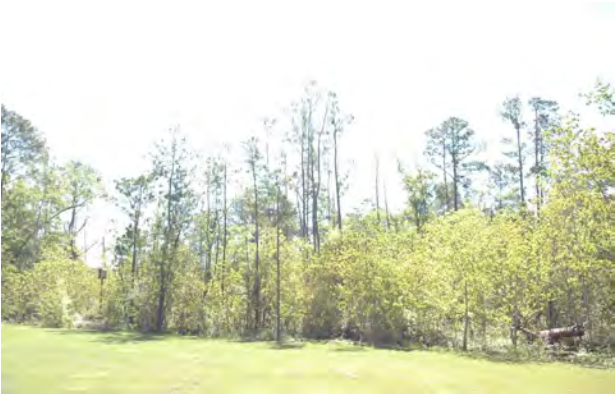
**Invasive Species** - Invasive Chinese Tallow should be controlled through mechanical and/or chemical means.

Chinese Tallow stand at eastern boundary.

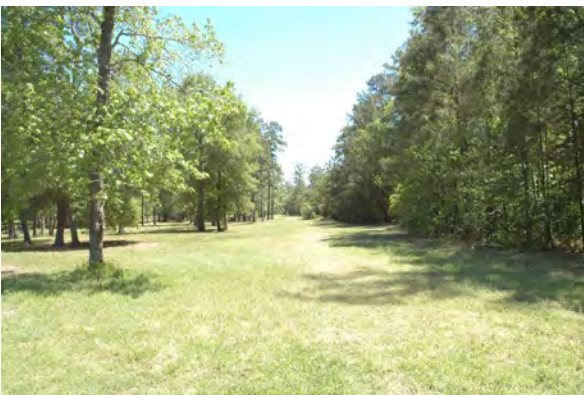
Available planting space found near the lower pond.

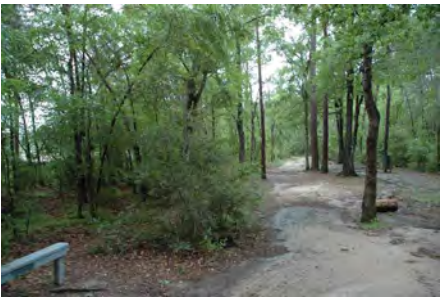
Erosion noted within disc golf areas of the forest.

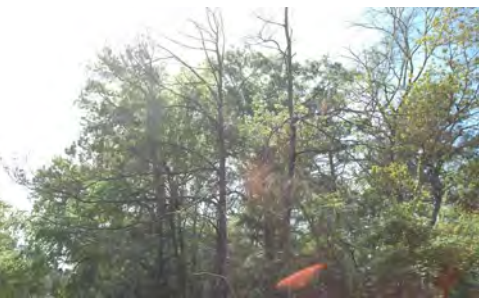
**Safety** - Dead trees within the Camberwell Ct. reserve should be removed, as they present potential hazard due to proximity to backyards.

Dead trees noted within Camberwell Ct. reserve.

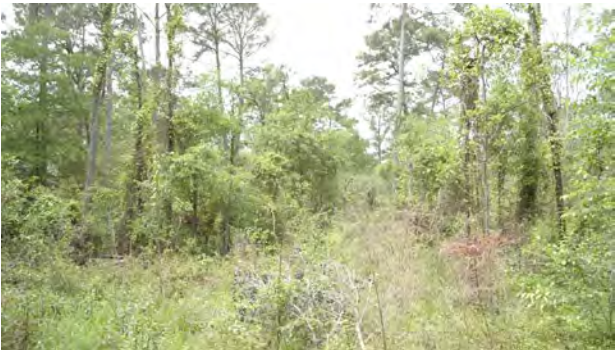
**Invasive Species** - Chinese Tallow is encroaching significantly on this understocked/disturbed site and should be controlled.

Edgewood Forest is ready for reforestation with some brush control measure for preparation.

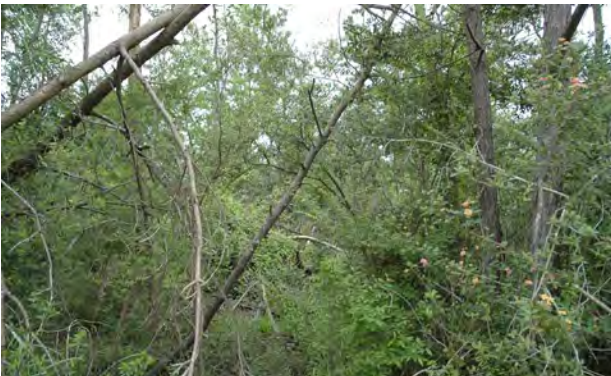
**Fire** - Fire risk is relatively low due to width, though understory vegetation is tall and capable of creating 'fuel ladders' should a fire break out.

Tall understory vegetation with debris accumulation.

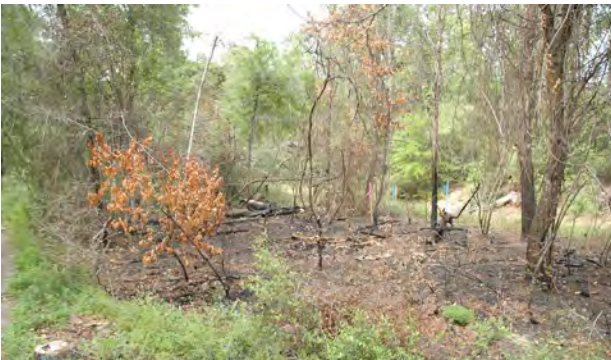
*A small fire scar was noted in Logger’s Hollow during site inspections. The cause of the fire is unknown however, the fire was limited to the space between the open drainage area and the walking path indicating the effectiveness of firebreaks.*

**Fire** - Fire risk is low to moderate due to fire-breaks, but evidently possible. The cause of the fire is unknown.

A small fire scar was found near the northern half of the reserve. Notably the fire did not cross the pathway and the drainage easement which acted as manmade and natural firebreaks.

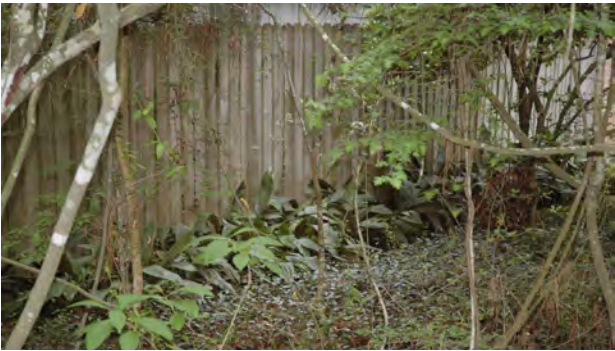
Non-native landscape materials have escaped from a neighboring landscape.

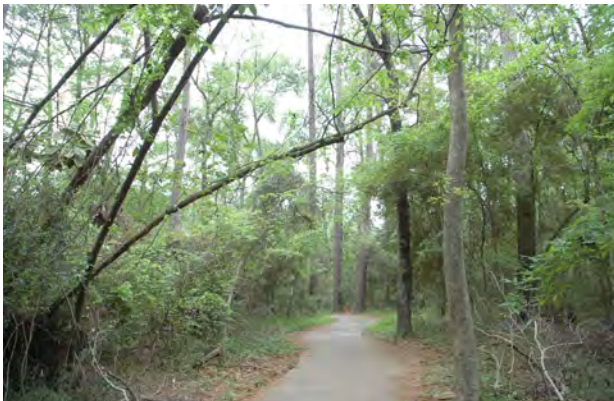
Typical view along the nature trail.

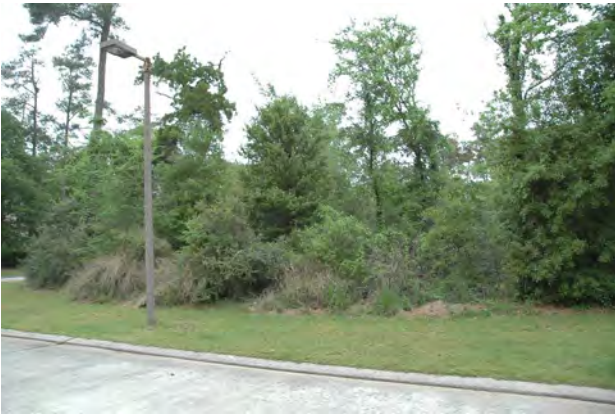
This reserve is dominated by understory vegetation with a few mature trees.

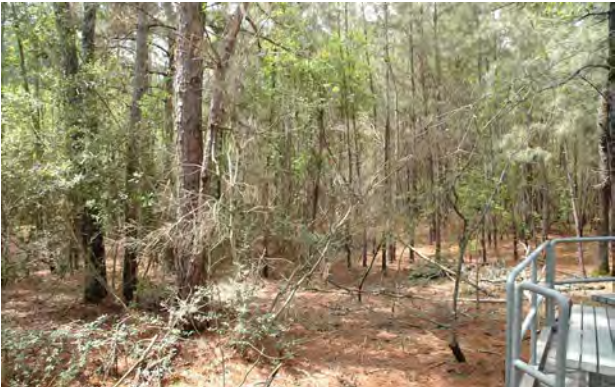
A healthy young stand of pine regeneration is actively growing within the peninsular area of the site.

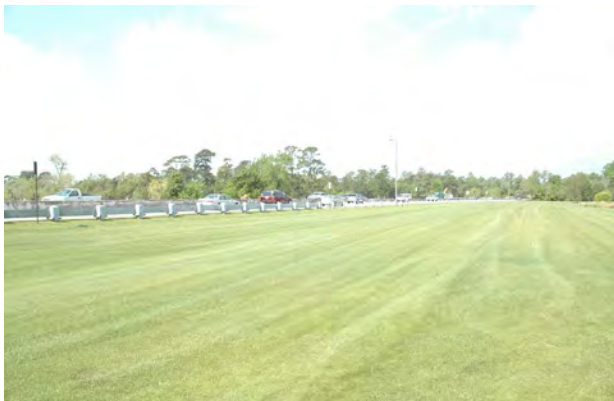
Significant planting space is available on this site, without detracting from the intended view.

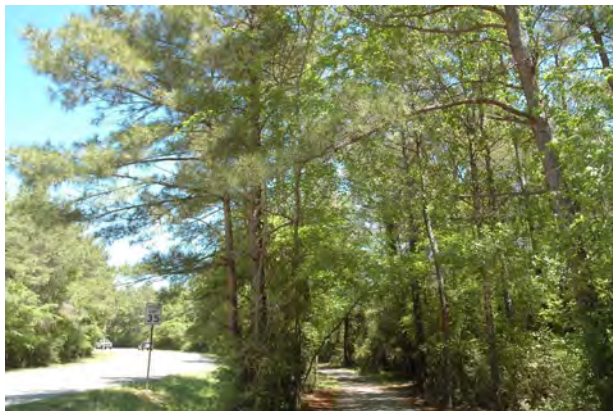
This narrow forested strip primarily serves as a buffer between the walking path and the road.

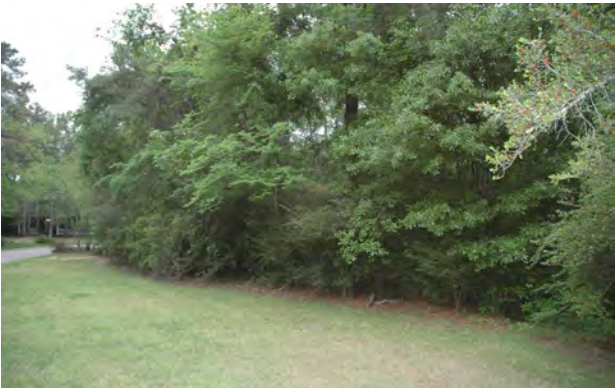
Available planting space near the road.

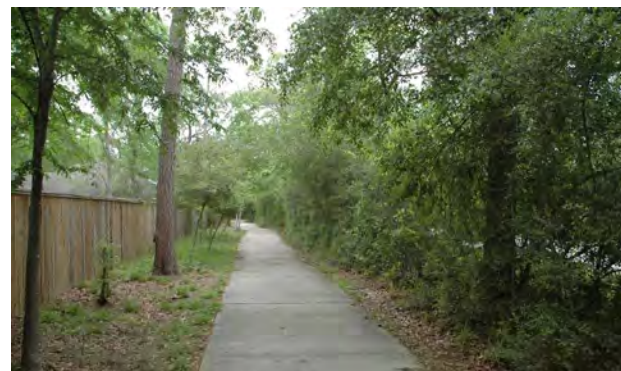
View along walking path. Some planting space is available for shade tolerant species.

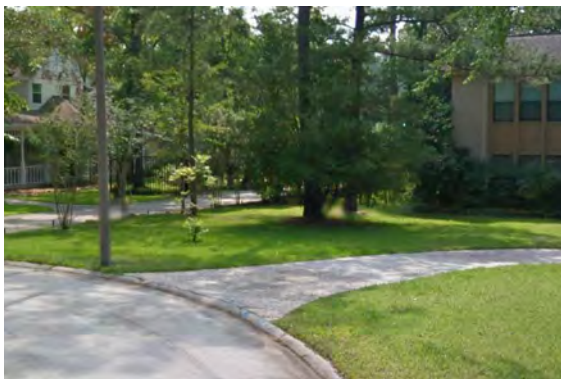
The reserve is a maintained landscape in between two houses.

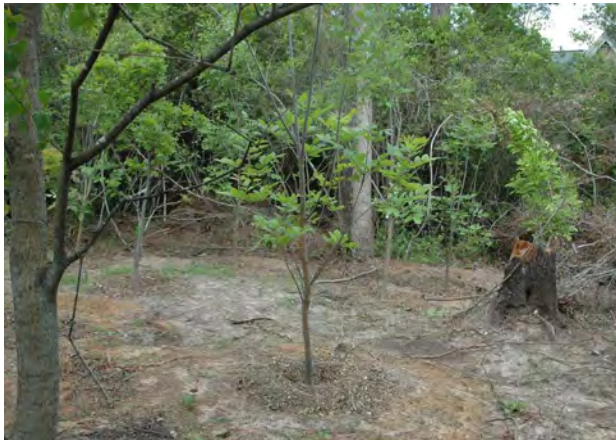
New hardwood plantings noted during inspection.

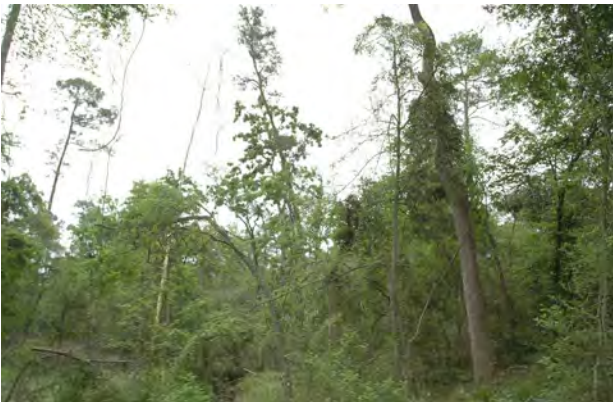
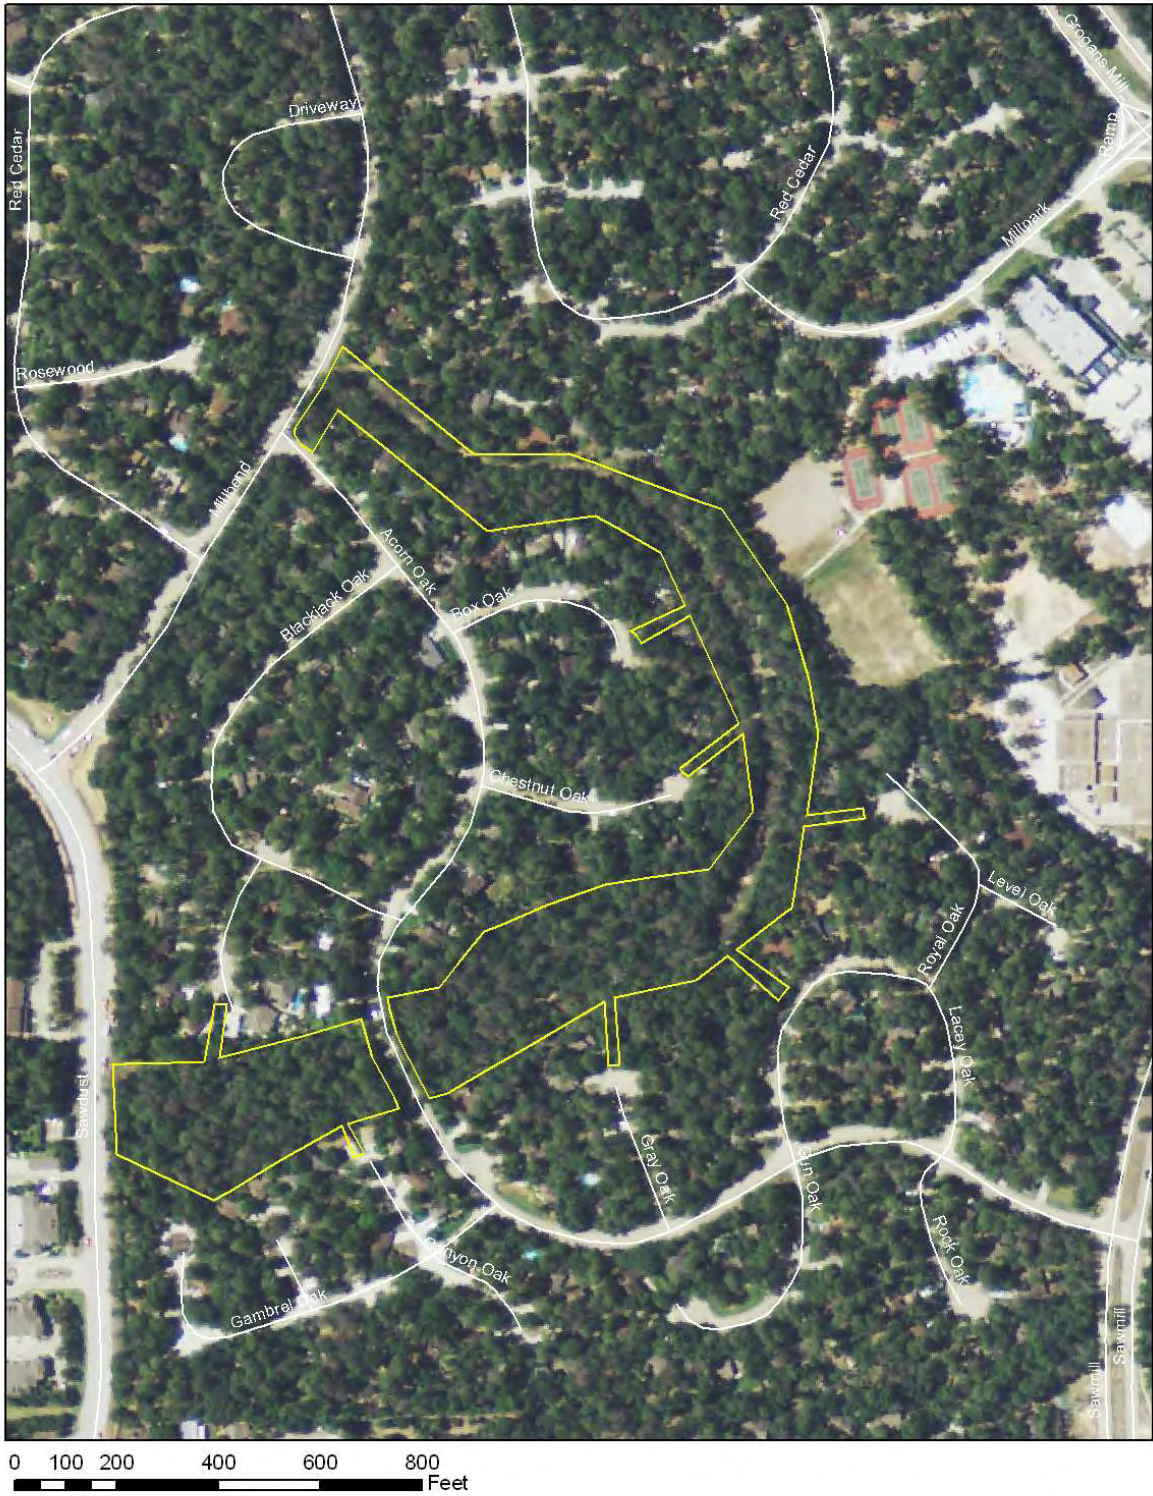
Woodfarm Common is a large reserve winding along a natural drainage through a neighborhood. The site has varied topography that offers both bottomland and upland forest stands. The forest is generally mature with open areas that are younger and dominated by understory vegetation. There is a rich variety of shrub, vine and herbaceous species. Some dead trees were noted, a few of which could present a hazard to neighboring yards. A number of trees have been removed recently. There is a walking path and some bridges running through the site. Excellent wildlife habitat is available with the access to water, browse and cover.

- Reforestation** - Abundant planting space is available. Some understory control may be needed prior to planting.
- Tree Health** - Overall healthy forest.
- Safety** - A few dead trees were noted that could fall into yards.
- Drainage** - Drainage is very adequate.
- Fire** - Fire risk is low to moderate. There is somewhat limited access.
- Invasive Species** - Confederate Jasmine, Burford Holly and Chinese Tallow were noted.

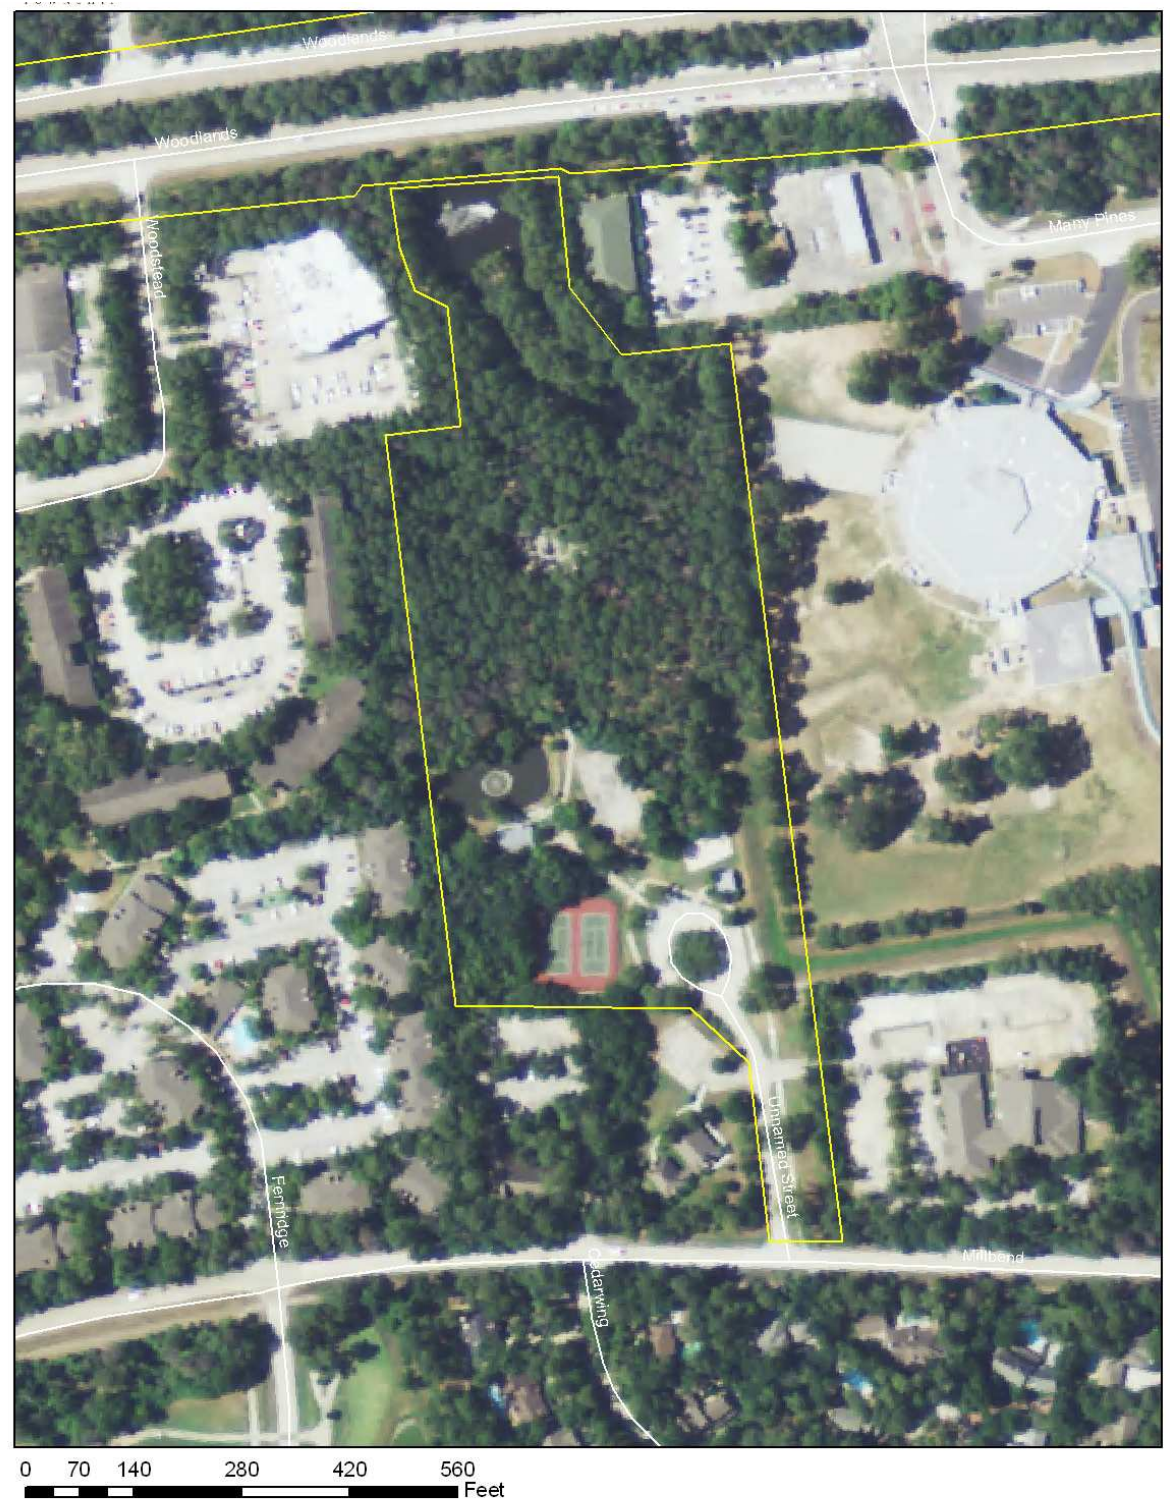
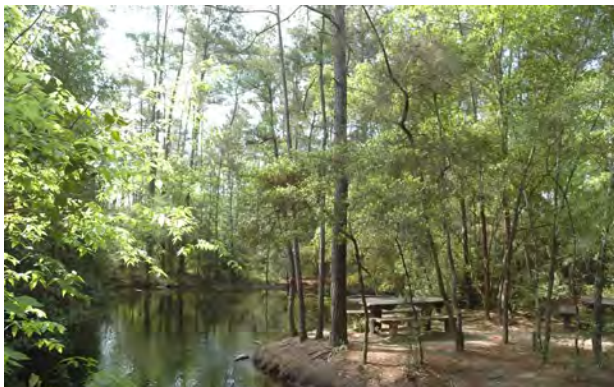
## TAMARACK PARK

**Safety** - No hazards were noted.

**Fire** - Fire risk is low to moderate. The ponds and road act as fire breaks.

**Invasive Species** - No invasive species were noted.
