# The Woodlands Township

Pond and Lake Management Plan

February 2011

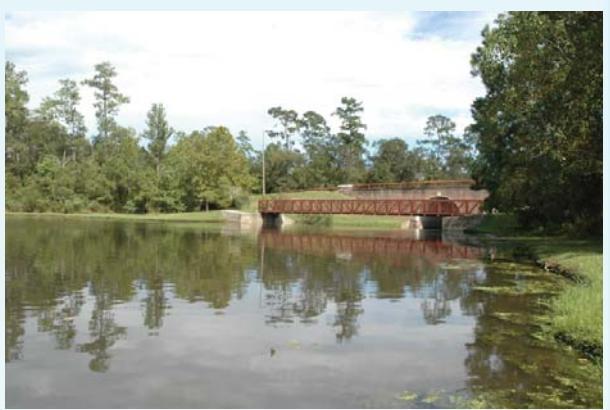
View of upper pond near the bridge.

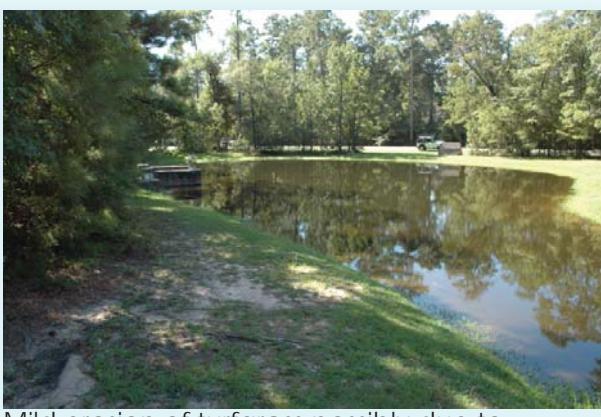
Mild erosion of turfgrass possibly due to compacted soils from foot traffic.

Alden Woods Pond is in healthy condition with an apparently balanced population of fish species in several size ranges, along with turtles, invertebrates and aquatic vegetation. Overall water quality indicates little need for improvement. The eroded turfgrass areas can be remedied by topdressing the soil with sand to provide as substrate for the St. Augustine grass to re-establish itself through stoloniferous growth.

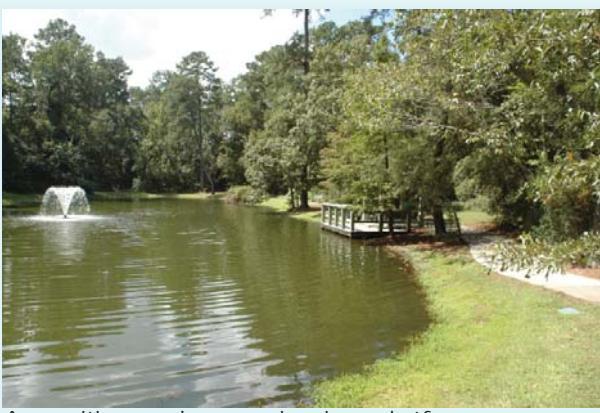
Amenities such as a viewing platform, benches and a picnic table provide excellent recreational opportunities at Deer Rush Pond.

Coastal Water Hyssop growing along the water's edge helps filter stormwater and prevent erosion.

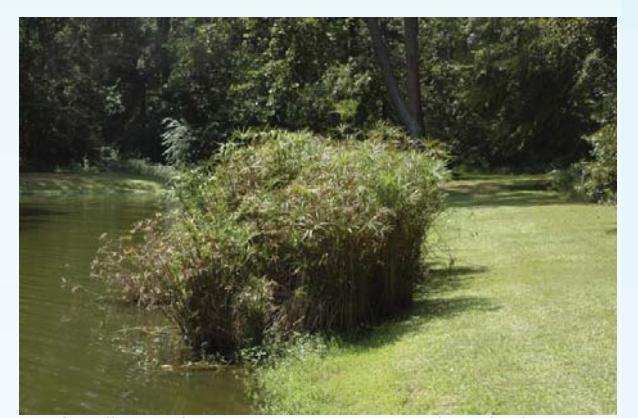
Umbrella sedge, a common wetland plant, can rapidly take over the banks of a small water body. Monitoring the growth of this plant is recommended.

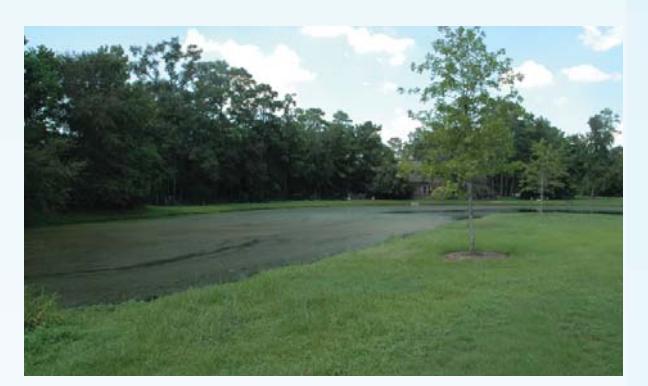
An algae bloom covered approximately 60% of the pond surface. This growth can be caused by excess nitrogen and phosphorous from runoff stimulating the algae.

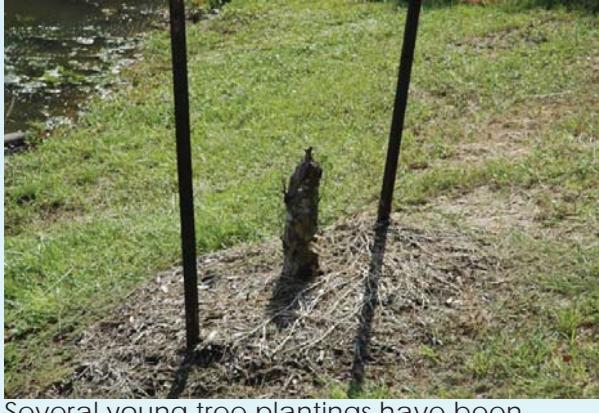
Several young tree plantings have been destroyed by nutrea. No beaver dams were found on site. To prevent damage to trees, wire mesh cages can be erected around the trunk to a height of three feet to discourage gnawing

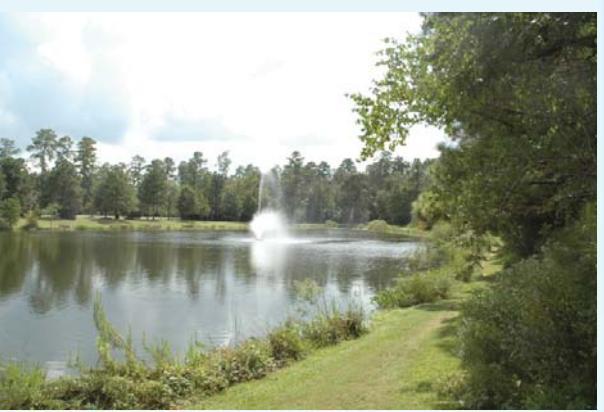
Heavy misting was of the fountain spray can cause excessive loss of water due to evaporation. Adjusting the pump pressure may reduce this effect if the feature is available on that fountain model.
